NWSC Environmental Health & Safety

Summary Report

► **CLIENT:** NCTC – TRF AVIATION CAMPUS
► **DATE:** Sept. 22, 2017
► **CONDUCTED BY:** BRIAN BYKLUM

Swenson Hanger

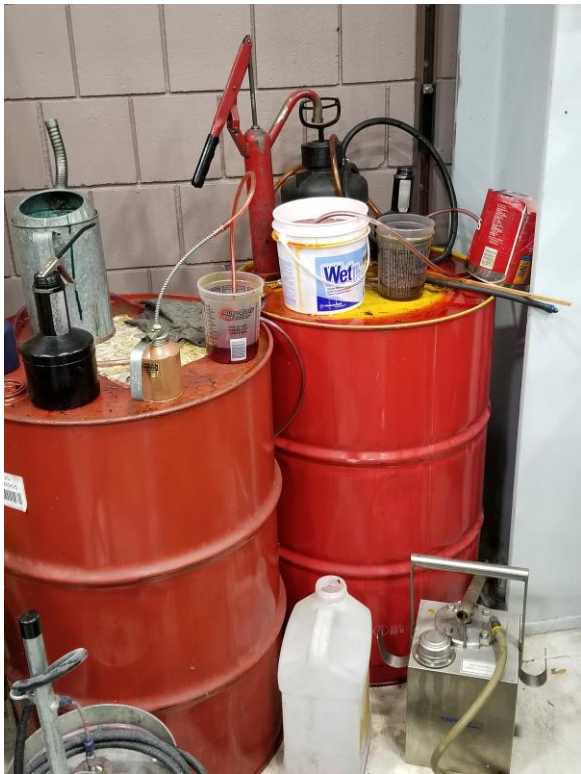
1

1. An unlabeled oil container was noted and oil was not cleaned up on top of 55 gallon drum.
2. A compressed gas cylinder was not stored properly.
3. A blocked exit was noted, exits must remain clear at all times.

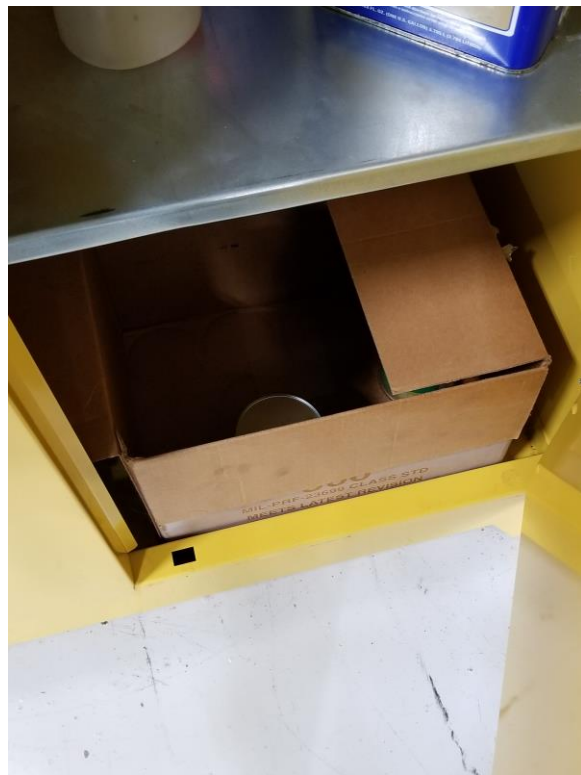
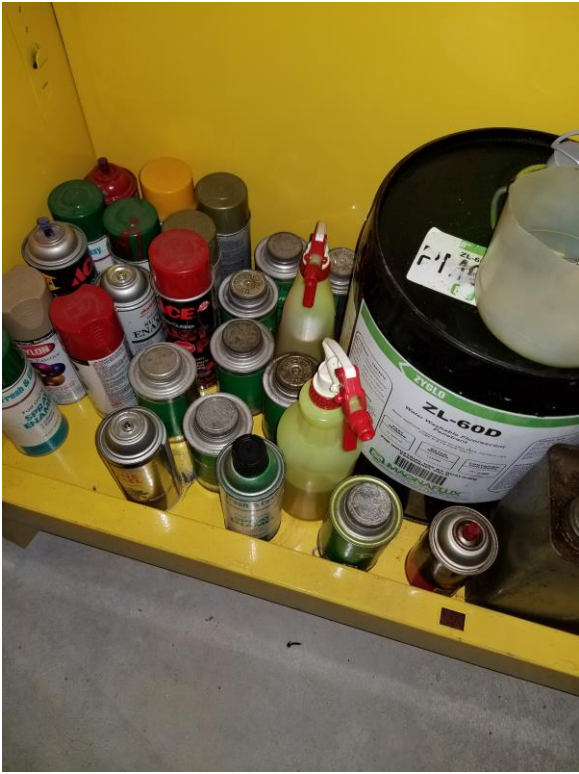
11

9. An open junction box was noted in the sprinkler room.
10. An unguarded belt and pulley system was noted on the alternator testing equipment.
11. An unlabeled secondary container was noted in the flammables cabinet and there were combustible materials stored in there as well.

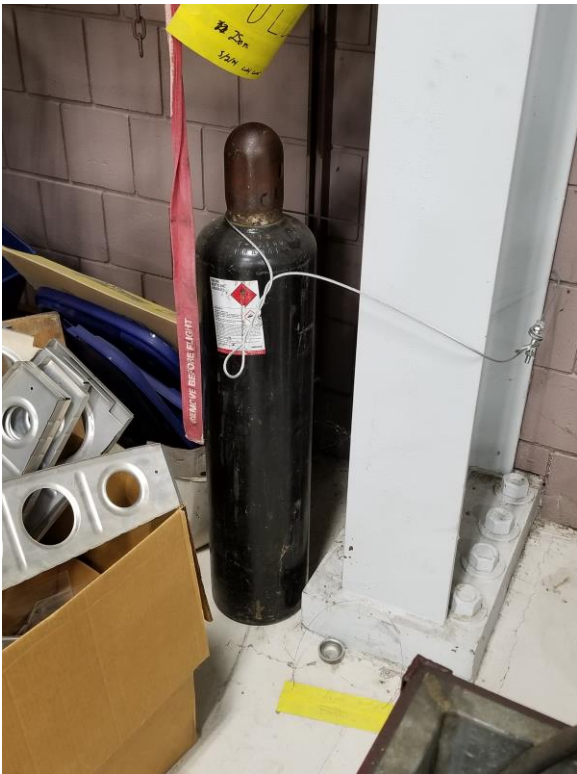
4

4. An acetylene cylinder was not store properly, oxygen cylinder was stored within 20 feet. They must be separated by more than 20 ft or a fire rated barrier with a minimum ½ hr rating.

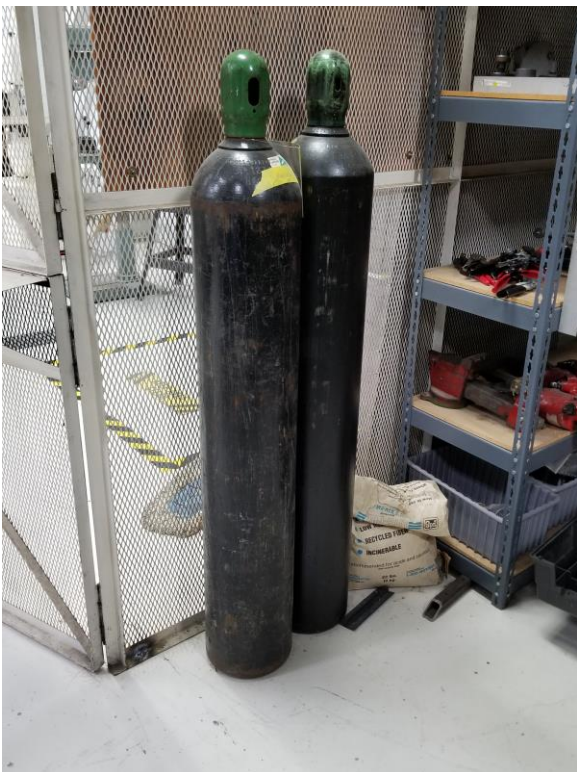
5

5. A nitrogen compressed gas cylinder was not secured properly.
6. A drill press was noted without a chip shield and was either not anchored to the floor or a larger base to prevent "walking".

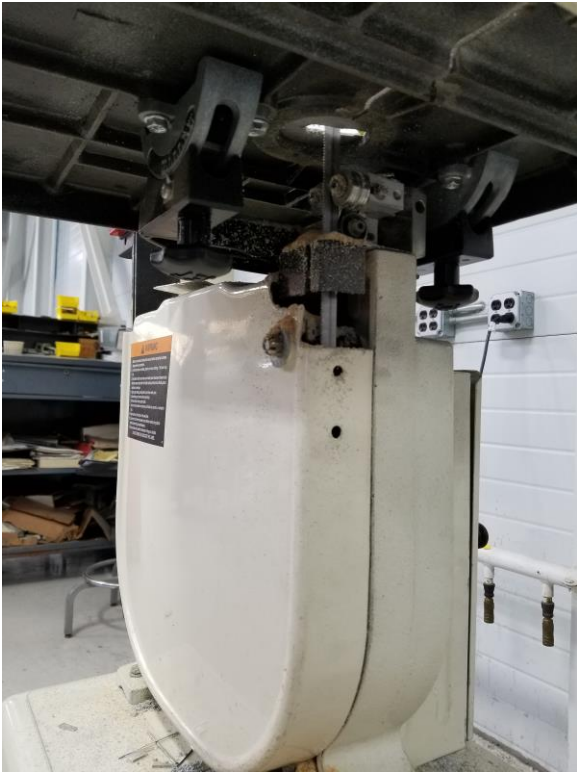
7

7. The Jet bandsaw was lacking a blade guard below the work surface.
8. Batteries are being stored with no secondary containment in the battery storage rooms.

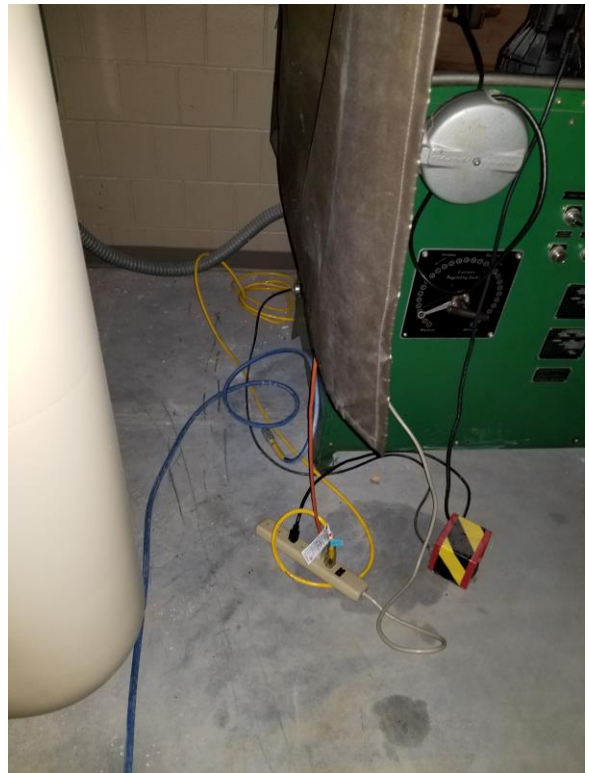
12

12. An extension cord was plugged into a power strip by the magna flux machine.
13. A garbage bag with used oil filters was leaking oil by the magna flux machine. Used oil and filters need to be disposed of properly.

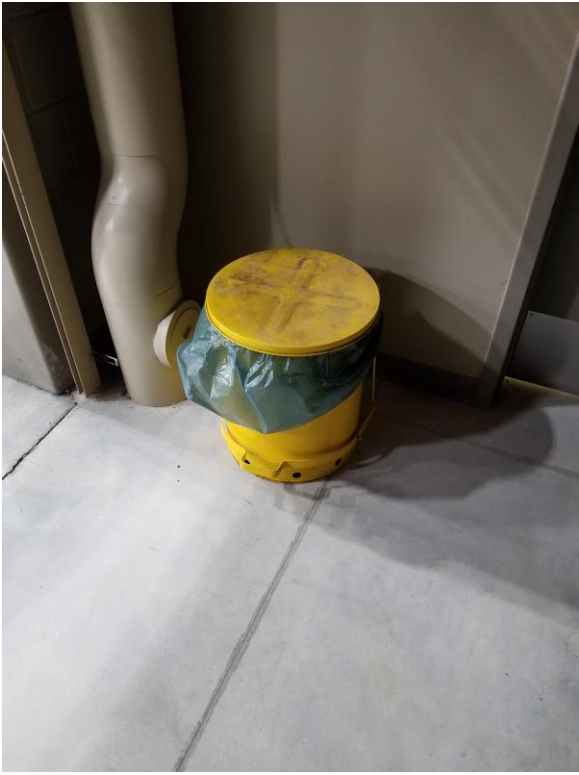
14

14. A flammable storage can was noted to be lined with a plastic bag. They should not be lined with plastic and must be emptied every day.
15. The torch was not equipped with anti-flashback devices. Recommend that they be purchased and installed.

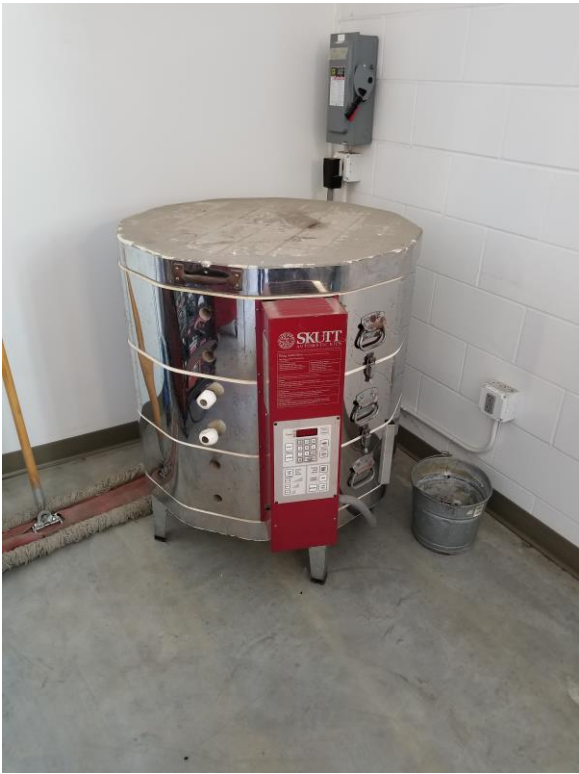
16

16. There is not ventilation for the kiln and SFM requires the kiln to be a minimum of 18" from the walls.
17. A blocked exit was note in the UAS area.

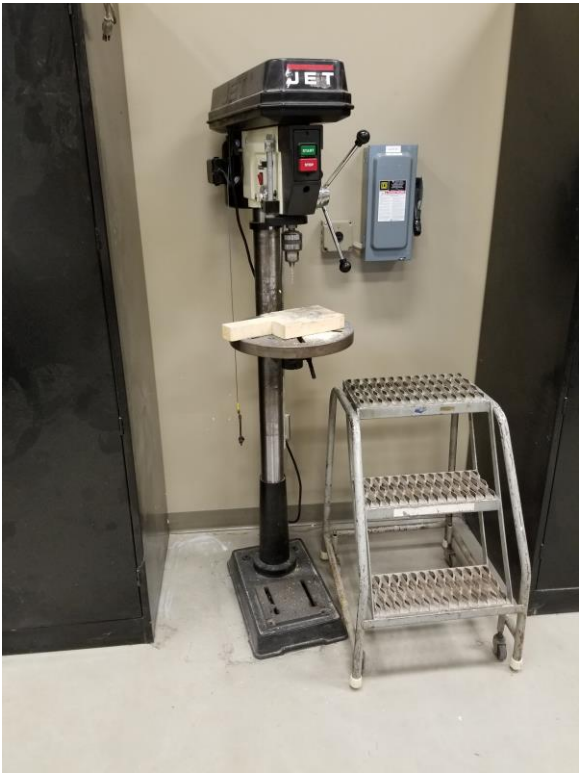
18

18. The drill press in the composite lab was not anchored and not equipped with a chip shield.
19. Rm 2 (electrical data) was missing ceiling tile, the fire extinguisher was not mounted on wall or signed. There was an open junction box above the door and two batteries were stored with no secondary containment.
20. Rm 2A (mechanical) had a metal box fan that was not grounded and the blade guard had areas that were greater than 1/2". The portable eyewash station fluid was not changed per manufacturer recommendations and was not inspected weekly. Electrical panel F cover was not installed properly.
21. A damaged strain relief was noted on the Delfield cooler in the kitchen.
22. An unapproved gas can was noted in the maintenance area.
23. The housekeeping in the office workroom needs work.
24. There is an outlet in the office workroom that is missing a cover plate.
