NWSC Environmental Health & Safety

Summary Report

► **CLIENT:** NCTC – TRF MAIN CAMPUS
► **DATE:** Sept. 22, 2017
► **CONDUCTED BY:** BRIAN BYKLUM

Conducted a mock OSHA inspection and noted the following:

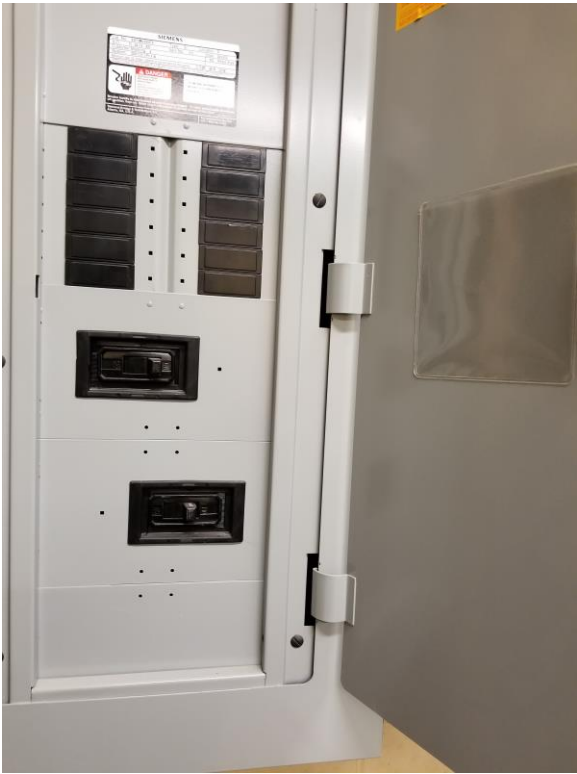
1

1. The breakers in the main panel in Rm 640 are not labeled as to what they control.

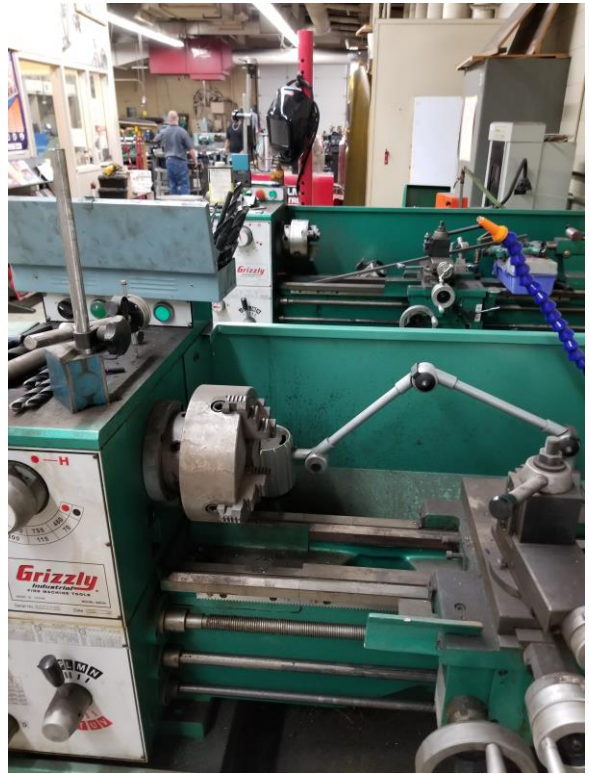
2

2. There are no chuck guards on the lathes. Purchase and install.
3. There is no chip shield on the milling machines. Purchase and install.
4. There is a damaged strain relief on a welder cord in booth 10.
5. A 4" grinder is missing the cup guard, install guard.
6. The Ellis horizontal bandsaw has an exposed blade, blade guard has to be adjust every time you cut a different size stock.
7. The cord for the foot pedal of the HTE shear is damaged.
8. Unlabeled secondary containers were noted. Containers must have name of product and any hazard warnings.
9. The exit to the east is blocked with material on the exterior of the building (see photo).

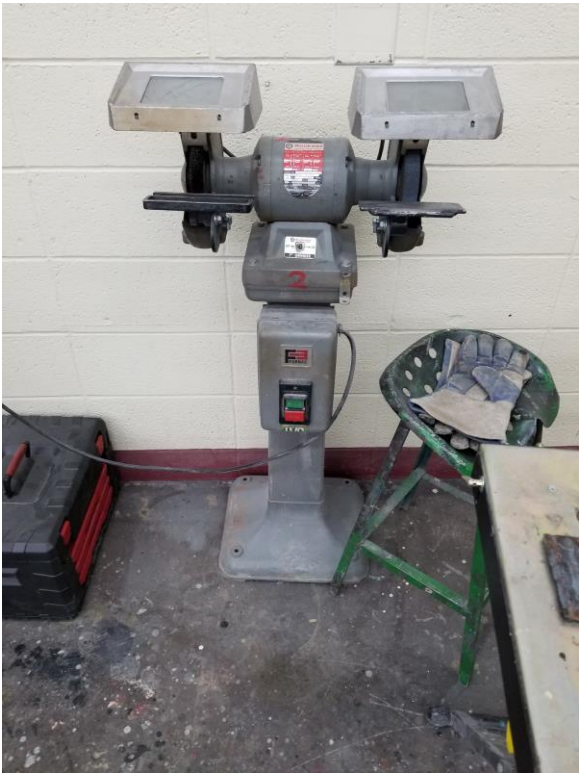
10

10. The Rockwell pedestal grinder must either be anchored to the floor or have a larger base to prevent "walking" when in use.
11. Hoses must be put away at end of the day or they present a tripping hazard.
12. There is a blocked exit, this must remain clear at all times.
13. The fire extinguisher is blocked.
14. There is no cup guard on a Flex 7" grinder. Install guard.
15. The coating on an orange extension cord was damaged, recommend it be removed or repaired.

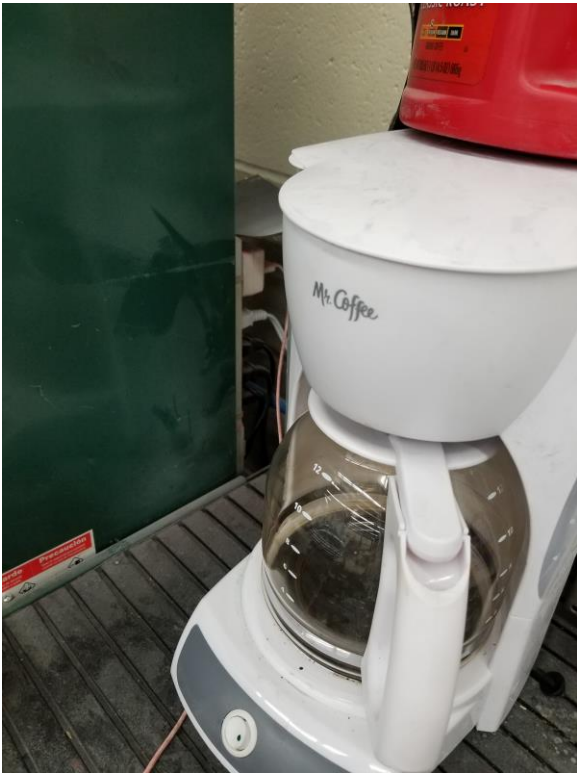
16

16. A coffee was plugged into a power strip and also not commercially UL listed.
17. An unapproved air nozzle was noted. Max outlet pressure can not exceed 30 psi.
18. Unlabeled secondary containers were noted in the flammables cabinet.
19. A red extension cord was missing the ground pin. Replace the plug end.
20. The drill press is not equipped with a chip shield.
21. The respirator is not stored properly. Must be cleaned, dried and stored in a dust free environment.
22. The sprinkler head in the paint booth is covered with a paperbag that is held in place with a nylon zip tie. Recommend that the zip tie be removed and a rubber band be used instead.
23. There are no safety clips on the hooks of the cherry picker.

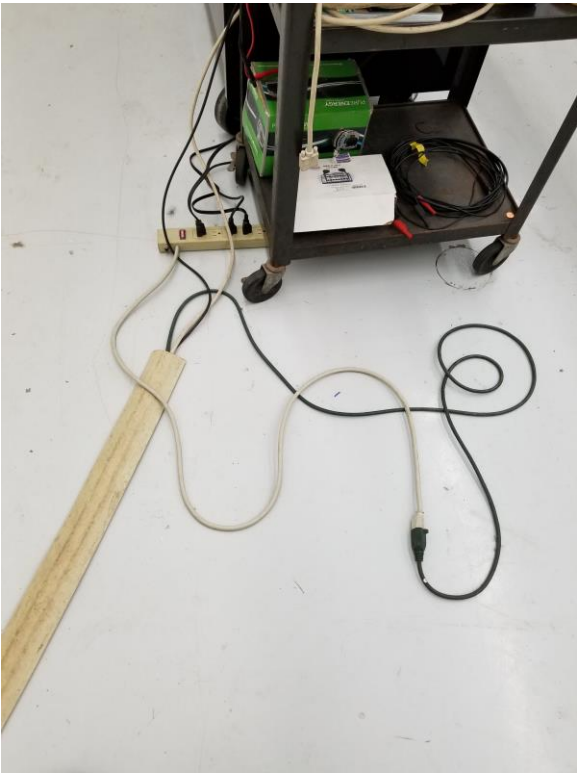
24

24. An extension cord was plugged into a power strip in Rm 723.
25. Hoses not picked up, no chip shield on drill press and there are no tire changing posters in Rm 729.
26. There is a taped strain relief on a drop cord.
27. A metal box with broken blade guards was noted, recommend that it be disposed of.
28. No chip shield on Jet table top drill press.
29. The combustible rag can was lined with a plastic bag.

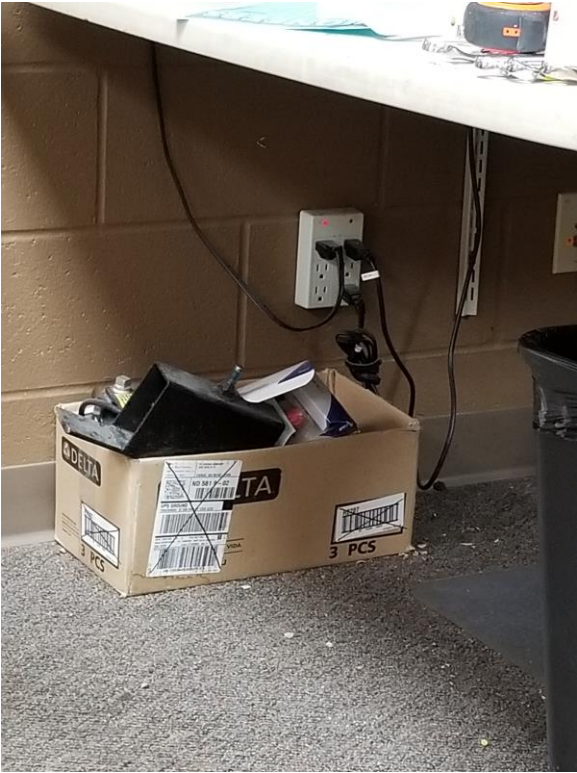
30

30. A six way plug adapter was noted in the maintenance office.
31. Housekeeping on the work bench needs work.
32. There is no chip shield on the bench top drill press.
33. A damaged strain relief was noted on a floor buffer.
34. Wood dust was present on the floor and around the miter saw, recommend that this be cleaned after each use.
35. A damaged strain relief was noted on a battery charger in Rm 520C.
36. The portable eyewash in Rm 520C has not been changed per manufacturer recommendations and has not been inspected weekly.
37. The LP cylinder on the forklift was not shut off. This must be turned off after each use.

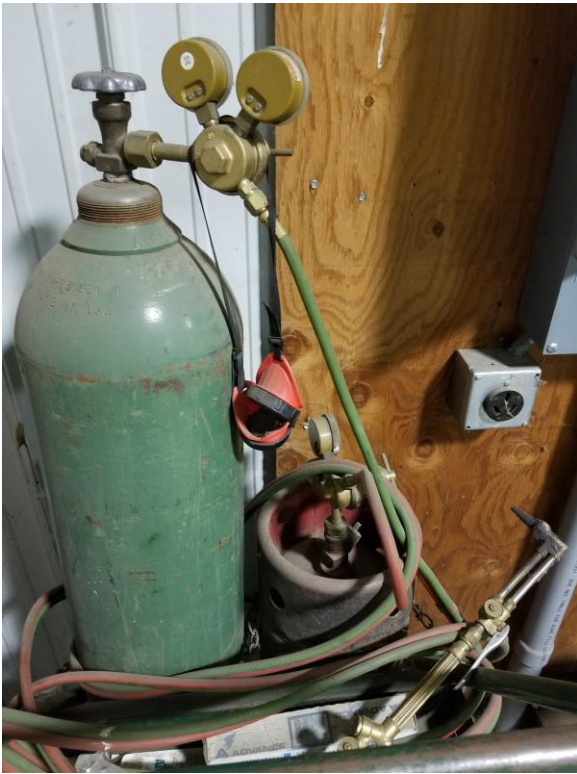
38

38. There are no anti-flashback devices on the torch.
39. Two 20 lb LP cylinders were being stored in the garage, these must be stored outside.
40. Secondary containers not labeled in main building garage.
41. An unapproved air nozzle was noted in the main building garage.

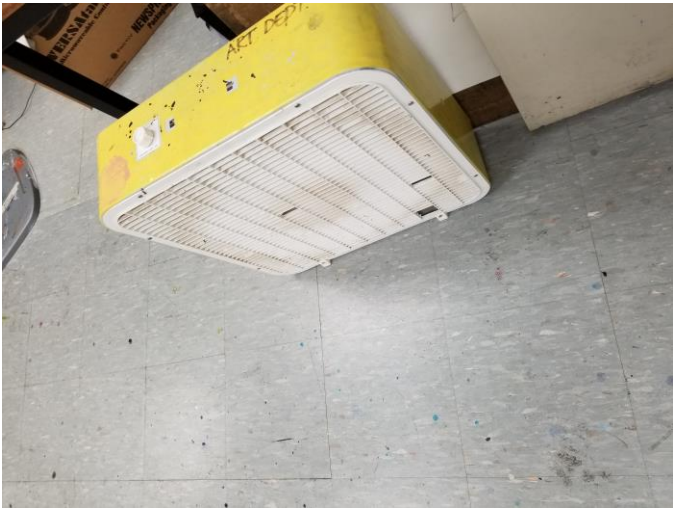
42

42. A box fan with a broken blade guard noted in Rm 431.
43. Rm 407A had missing ceiling tile and storage height issues.
44. A junction box with no cover was noted in Rm 410.
45. Rm 240 has housekeeping issues and the portable eyewash has not been changed according to manufacturer.
46. An open floor hole was noted in Rm 230. Ensure the cover is put back on.
