NWSC Environmental Health & Safety

Summary Report

► **CLIENT:** NCTC – TRF AVIATION CAMPUS
► **DATE:** Sept. 22, 2017
► **CONDUCTED BY:** BRIAN BYKLUM

Swenson Hanger

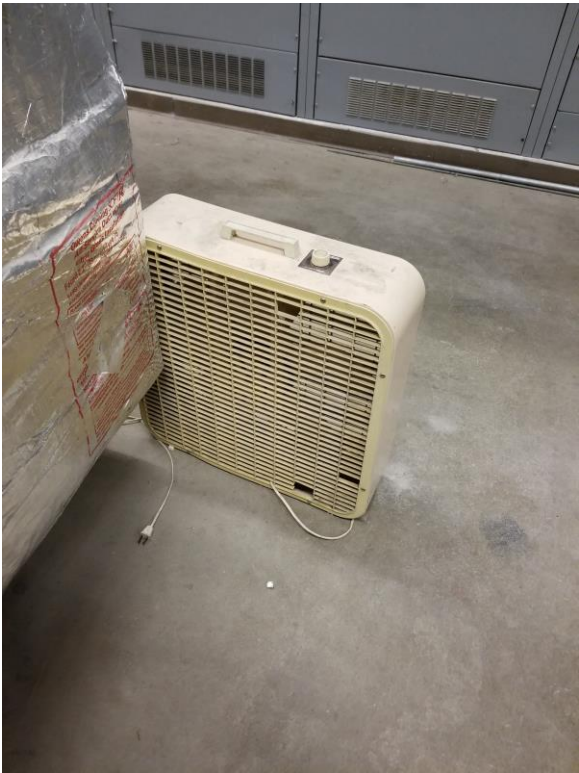
19

18. The drill press in the composite lab was not anchored and not equipped with a chip shield.
19. Rm 2 (electrical data) was missing ceiling tile, the fire extinguisher was not mounted on wall or signed. There was an open junction box above the door and two batteries were stored with no secondary containment.
20. Rm 2A (mechanical) had a metal box fan that was not grounded and the blade guard had areas that were greater than 1/2". The portable eyewash station fluid was not changed per manufacturer recommendations and was not inspected weekly. Electrical panel F cover was not installed properly.
21. A damaged strain relief was noted on the Delfield cooler in the kitchen.
22. An unapproved gas can was noted in the maintenance area.
23. The housekeeping in the office workroom needs work.
24. There is an outlet in the office workroom that is missing a cover plate.
